MEDICAL REPORT OF THE *D. Bonner*  
JOINT COMMISSION FOR THE INVESTIGATION  
OF THE EFFECTS OF THE ATOMIC BOMB IN JAPAN  
VOLUME 6

Populations and Casualties  
(Sections 10M and 10N)  
Building and Shielding Studies  
(Sections 11M and 11N)

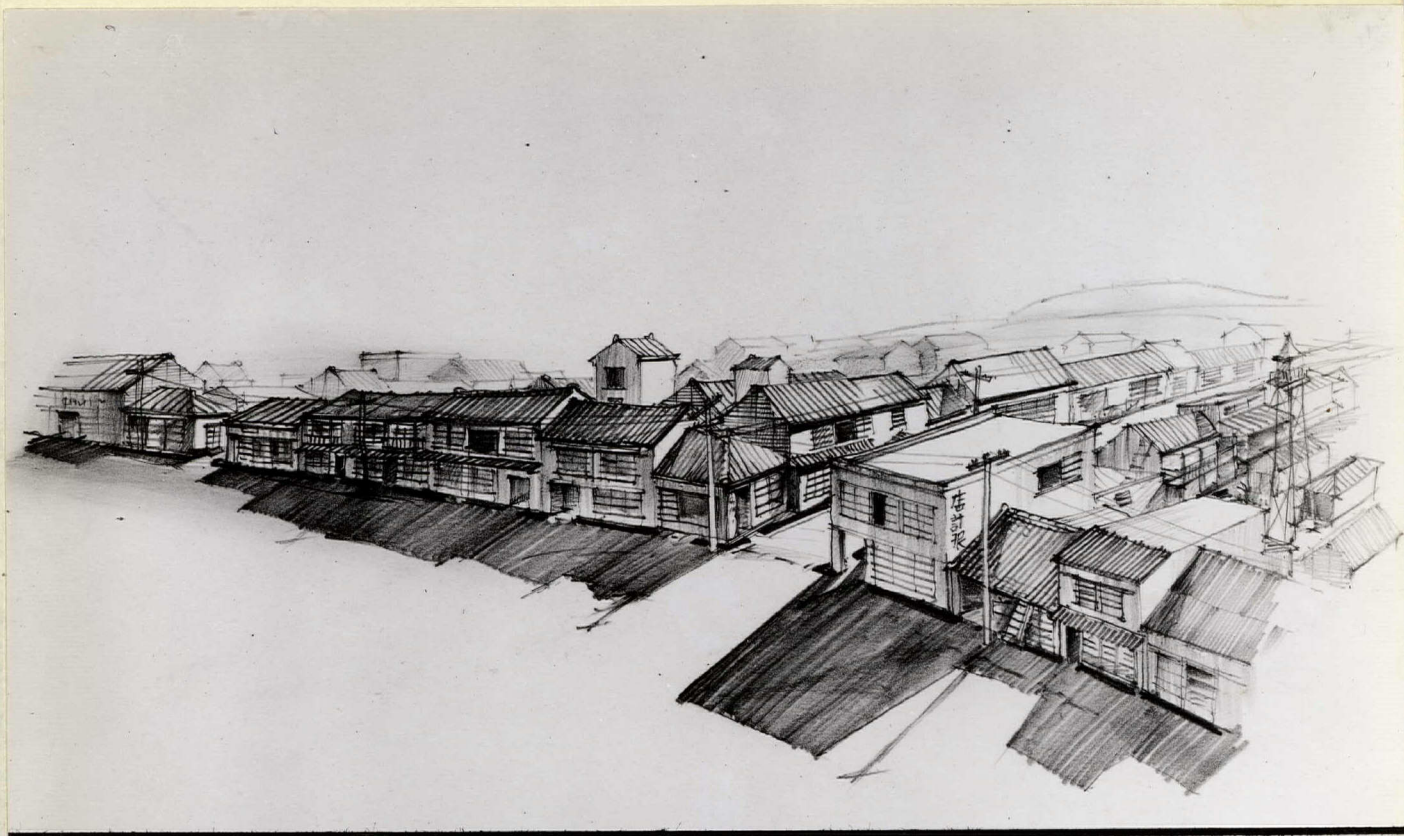
The lower sketch shows the relation of the scene to the bridge. The arrow points to the center of the explosion.

Figure 6 (10H). Bank of Tenna River. Tenna Bridge in background. Site under clearance for fire-break at the time of bombing by groups of men from Kuba, and Ogata (Tachido and Mitsurishi Villages). Almost all of these died of burns (see text page ).

a. A group of 106 individuals from Kuba village who were engaged in loading stone on the east bank of the Tenna River near the Tenna Bridge in the situation pictured in figure 6 all sustained severe burns. Forty-eight died on the spot or within 2 days, apparently as the result of burns. Most of forty-eight others died by 10 August, also apparently on account of burns but some lived until the 20th of August and 2 or 3 had evidence of radiation effect in addition to burns. Of the 10 who survived and in whom the burns healed, all had evidence of radiation effect and at the time of writing (20 November 1945) were still too weak to work. It may be assumed that those who died earlier also had radiation effects but these did not become manifest as sufficient time had not elapsed.

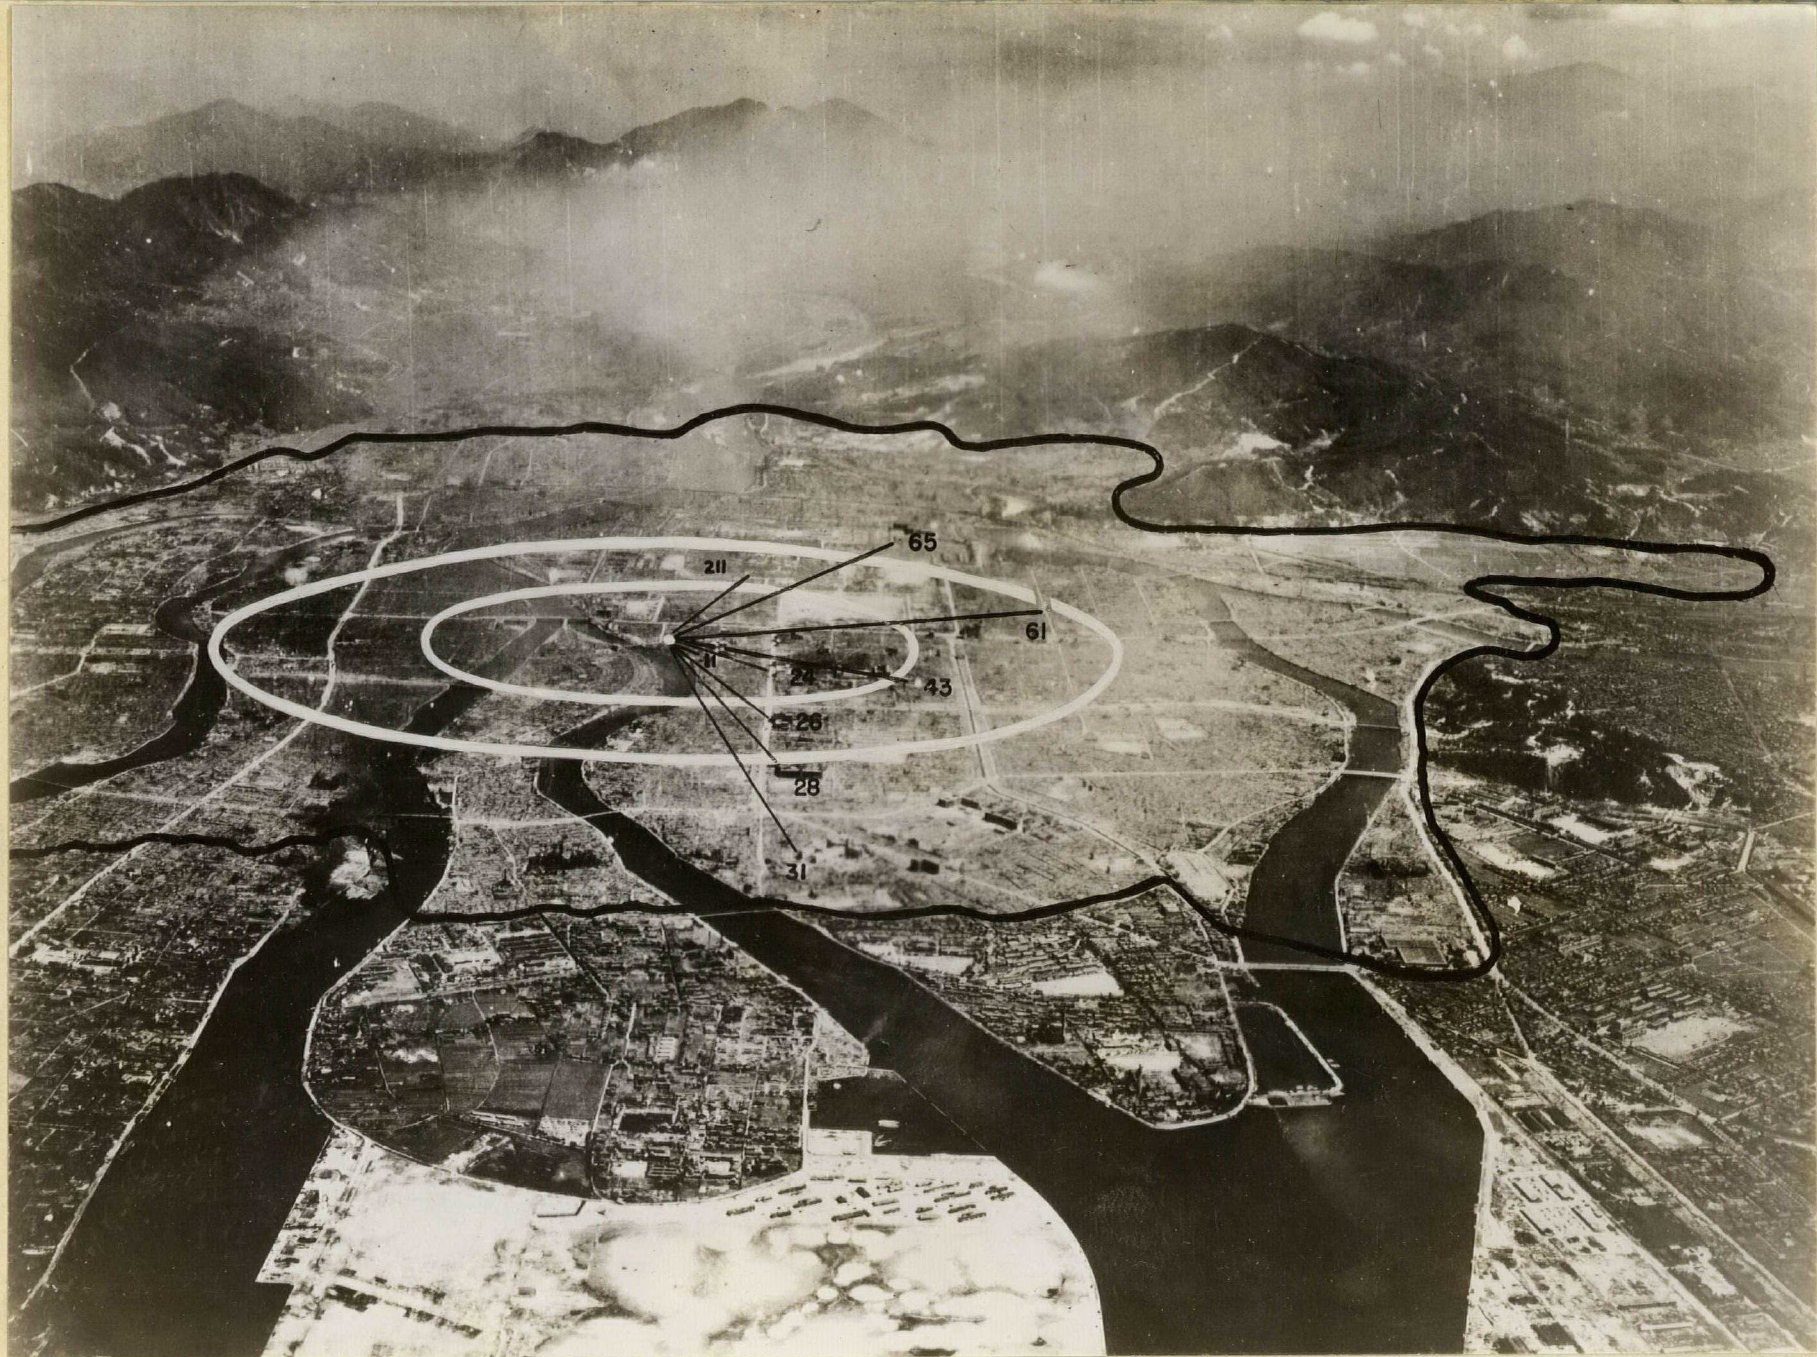
Figure 1 (11H). Buildings studied for correlation of shielding factors and survival. Radii are projected from the point above which the bomb exploded. The 500 and 1000 meter rings are indicated by the white circles. The zone of total destruction of the wooden buildings by blast and fire is outlined in black.

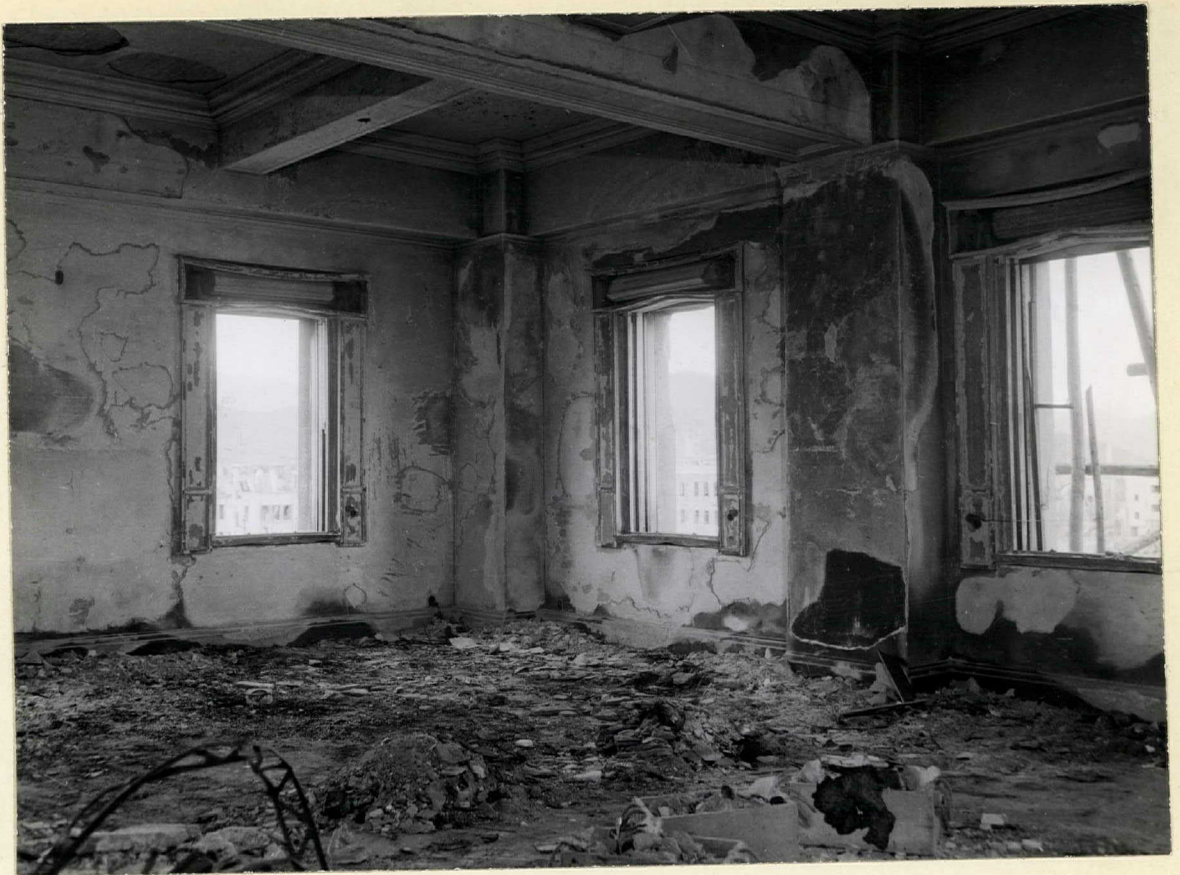
Figure 9 (11H) (450 meters). Nippon Bank. General view looking away from the center of the explosion. Optical axis of camera in line with point above which the bomb exploded.

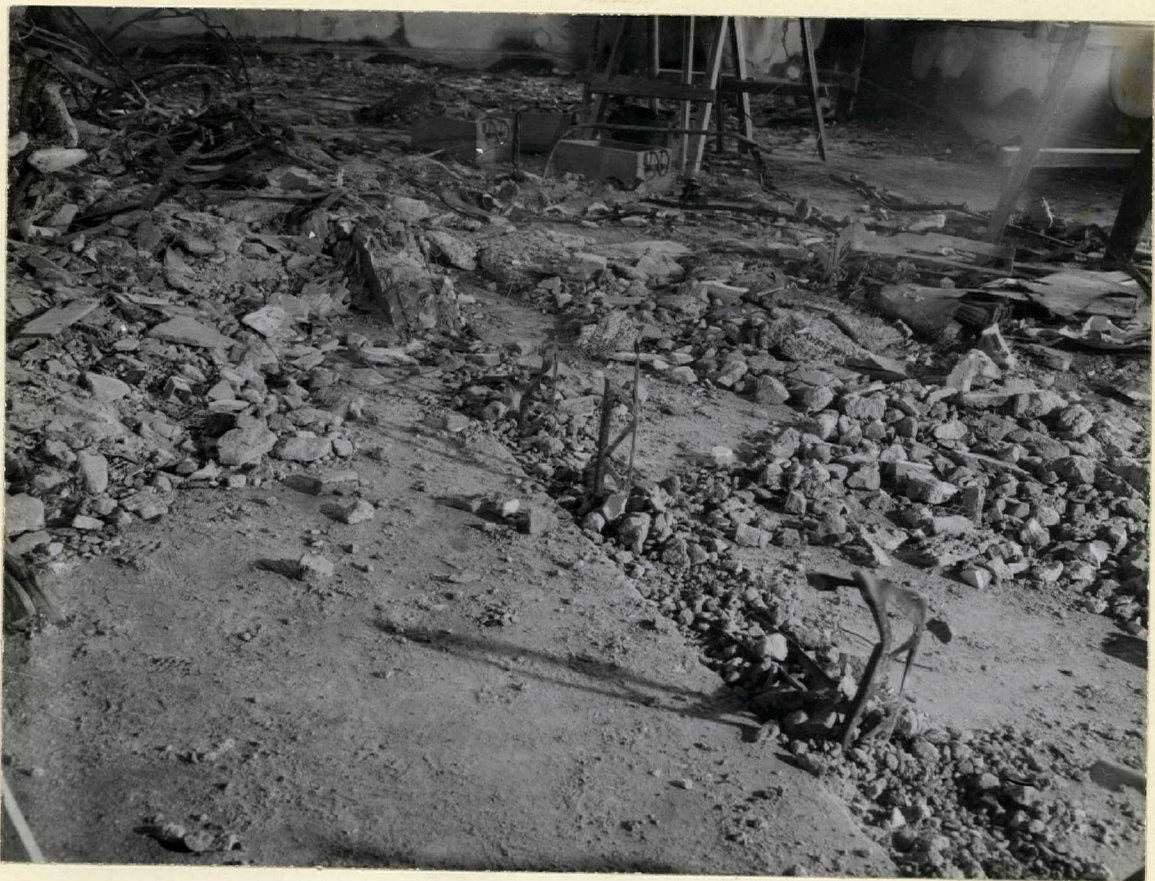
Figure 10 (11H). Nippon Bank (450 meters). Room - 1, third floor.  
Camera facing toward the point above which the bomb exploded.

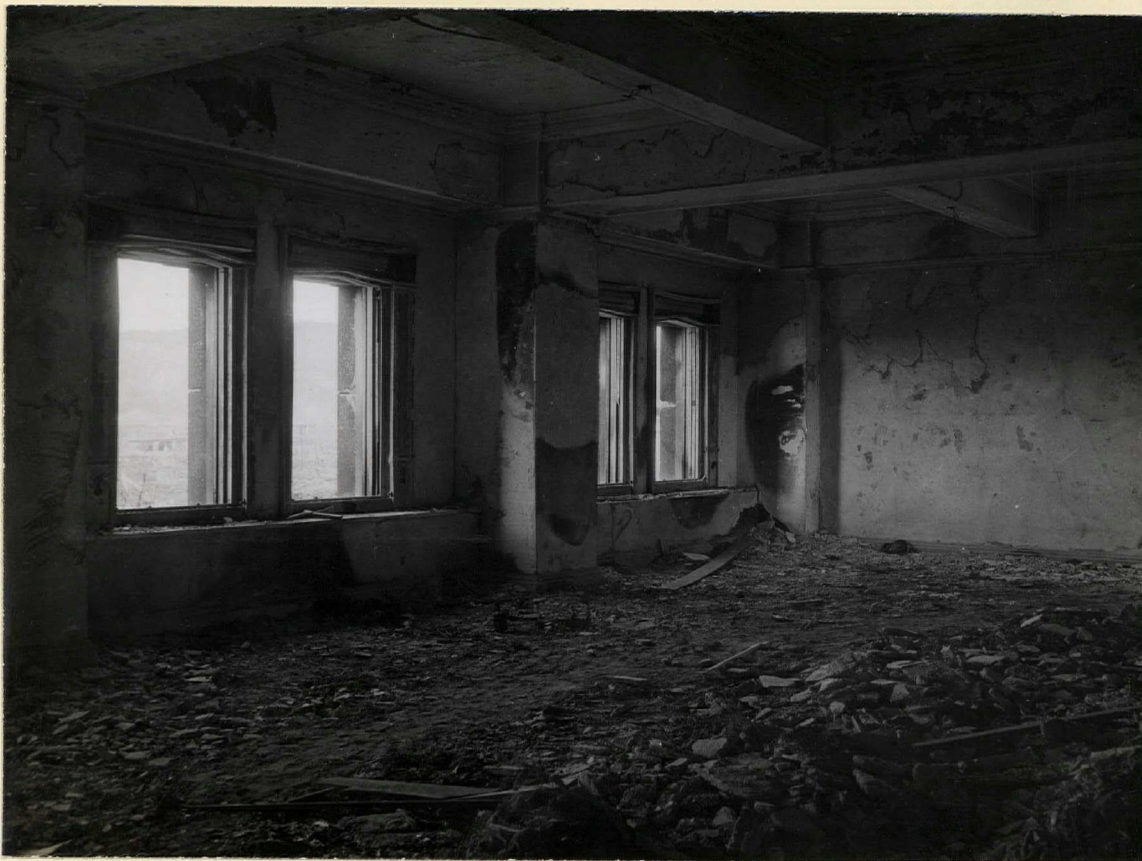
Figure 11 (11H). Nippon Bank (450 meters). Detail of partition between Room - 1 (third floor) and the hallway. Note the exposed metal reinforcements bent away from the explosion. A section of the partition remains showing its internal structure of cement and plaster, but most of it has crumbled into rubble.

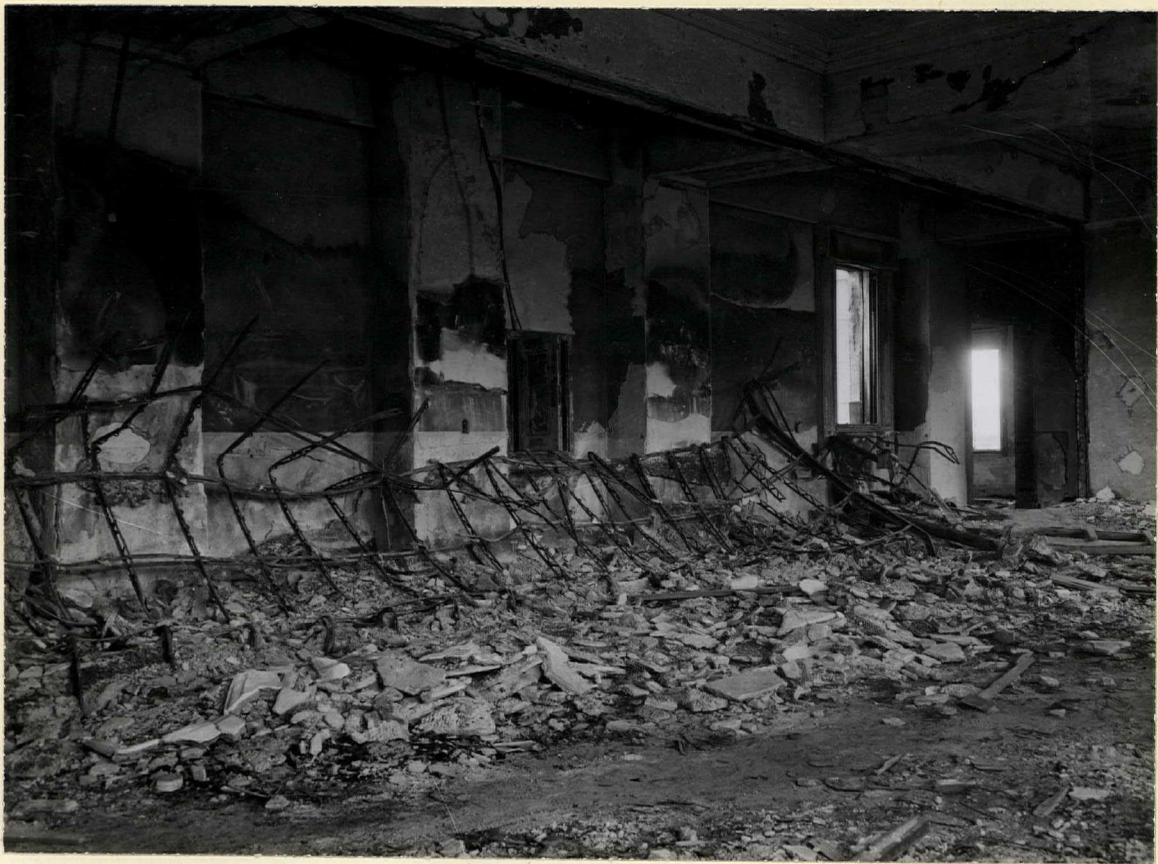
Figure 12 (11H). Nippon Bank (450 meters). Room - 3 (third floor).  
Camera facing the point above which the bomb exploded.

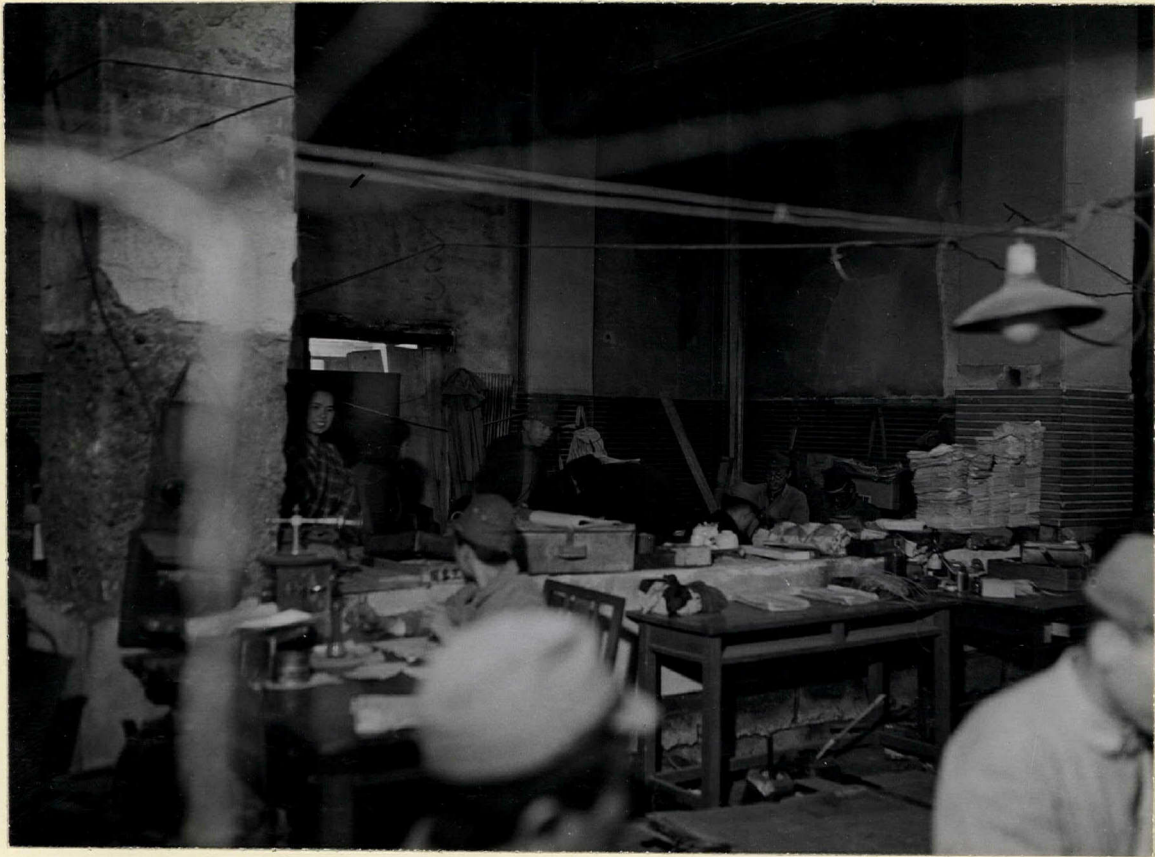
Figure 20 (11H). Telephone Bldg. (550 meters). General view looking away from the center of explosion, with which the optical axis of the camera is in line.

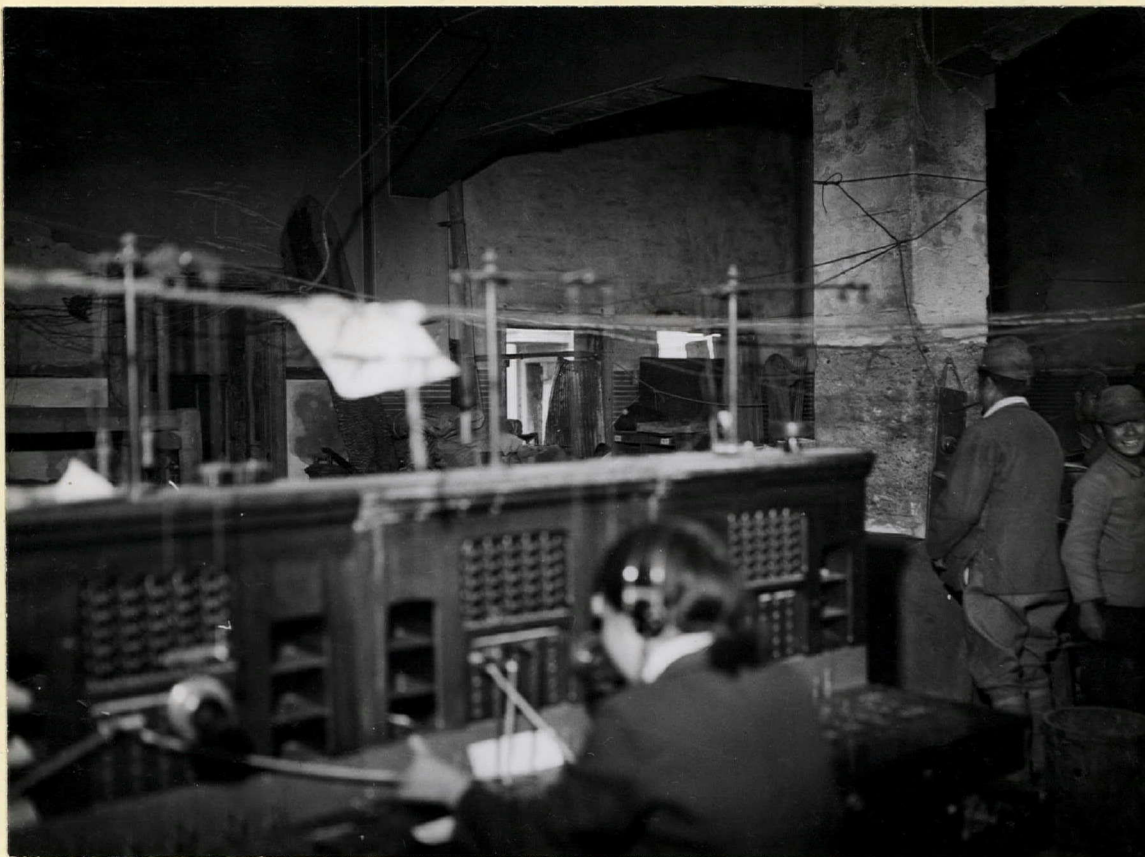
Figure 21 (11H). Telephone Bldg. (550 meters). Room I-C. First floor. Camera facing the center of the explosion.

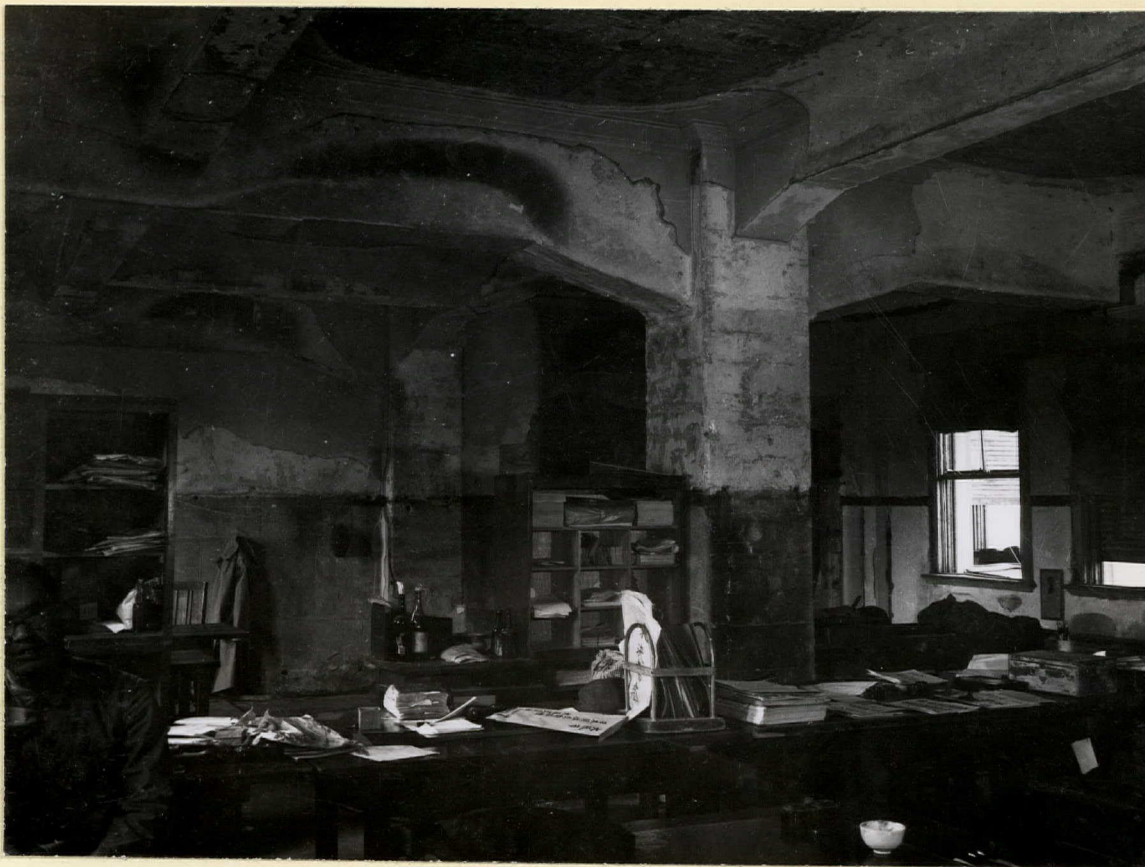
Figure 22 (11H). Telephone Bldg. (550 meters). Room I-D. First floor. Camera facing the center of the explosion.

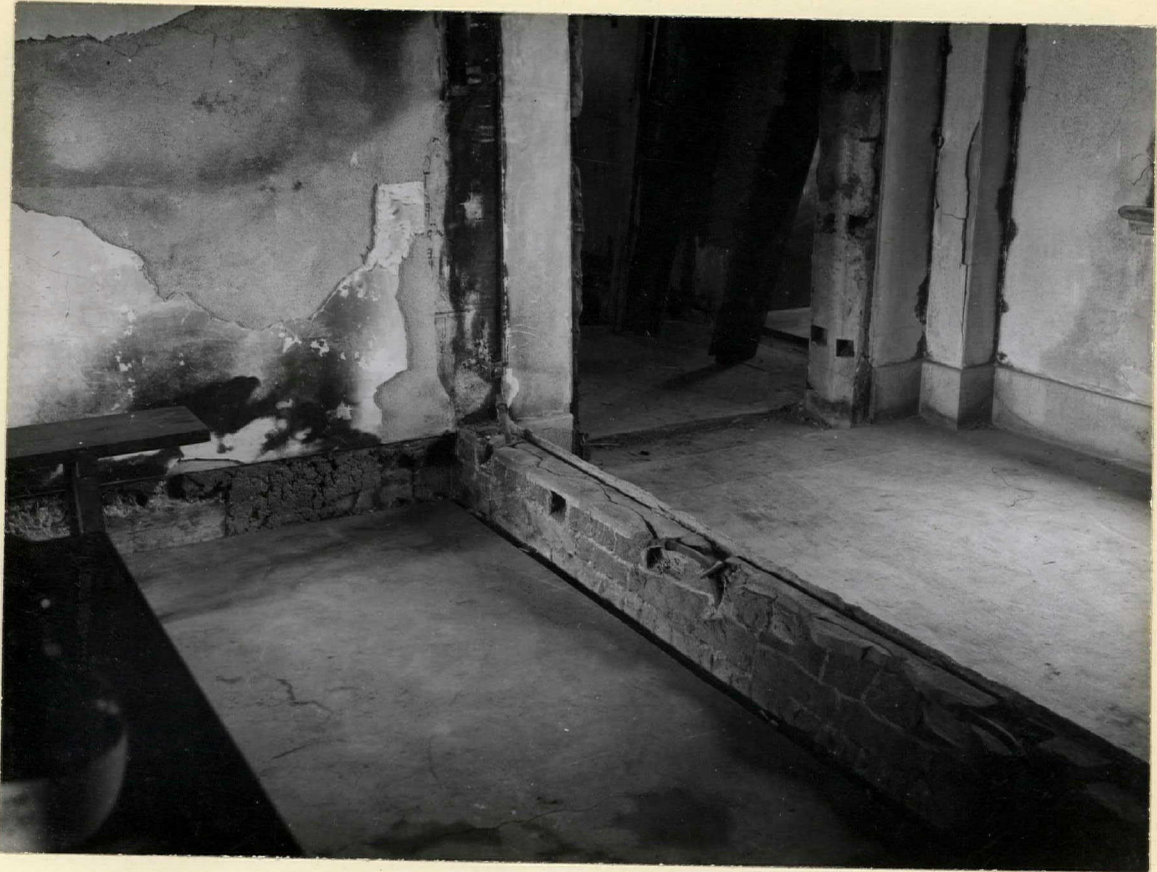
Figure 23 (11H). Telephone Bldg. (550 meters). Room A-2, second floor.  
Camera facing the center of the explosion.

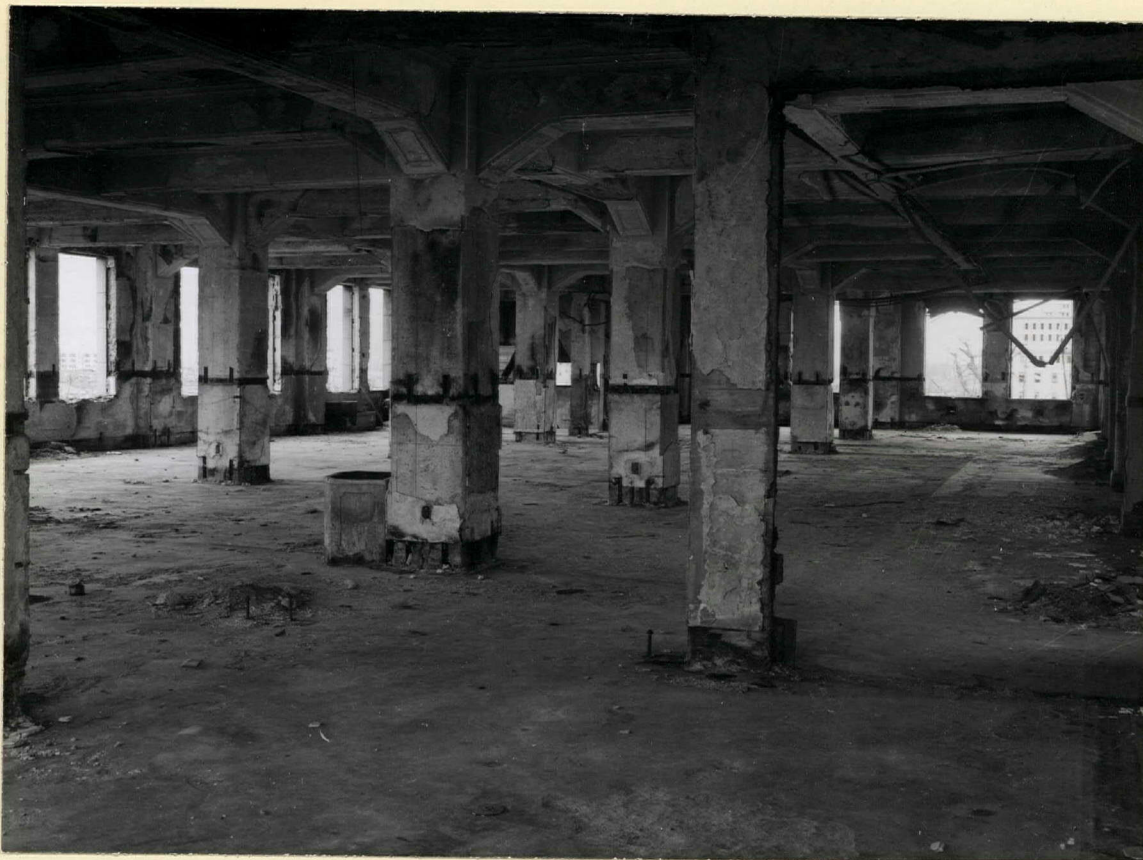
Figure 28 (11H). Chugoku Electric Bldg. (750 meters). General view looking away from the center of the explosion, with which the optical axis of the camera is in line.

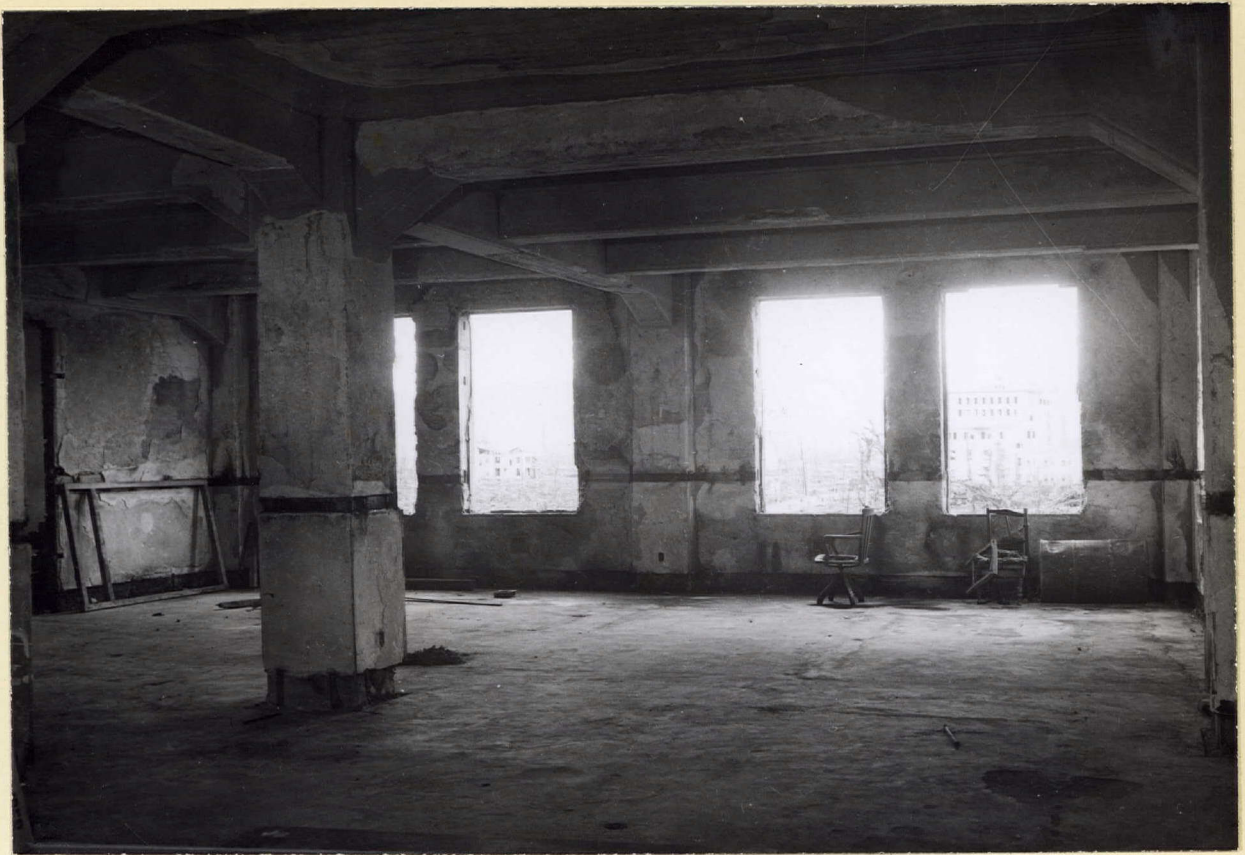
Figure 29 (11H). Chugoku Electric Bldg. (750 meters). Room III - 1, third floor. Looking toward the center of the explosion. Compare with figure 26.

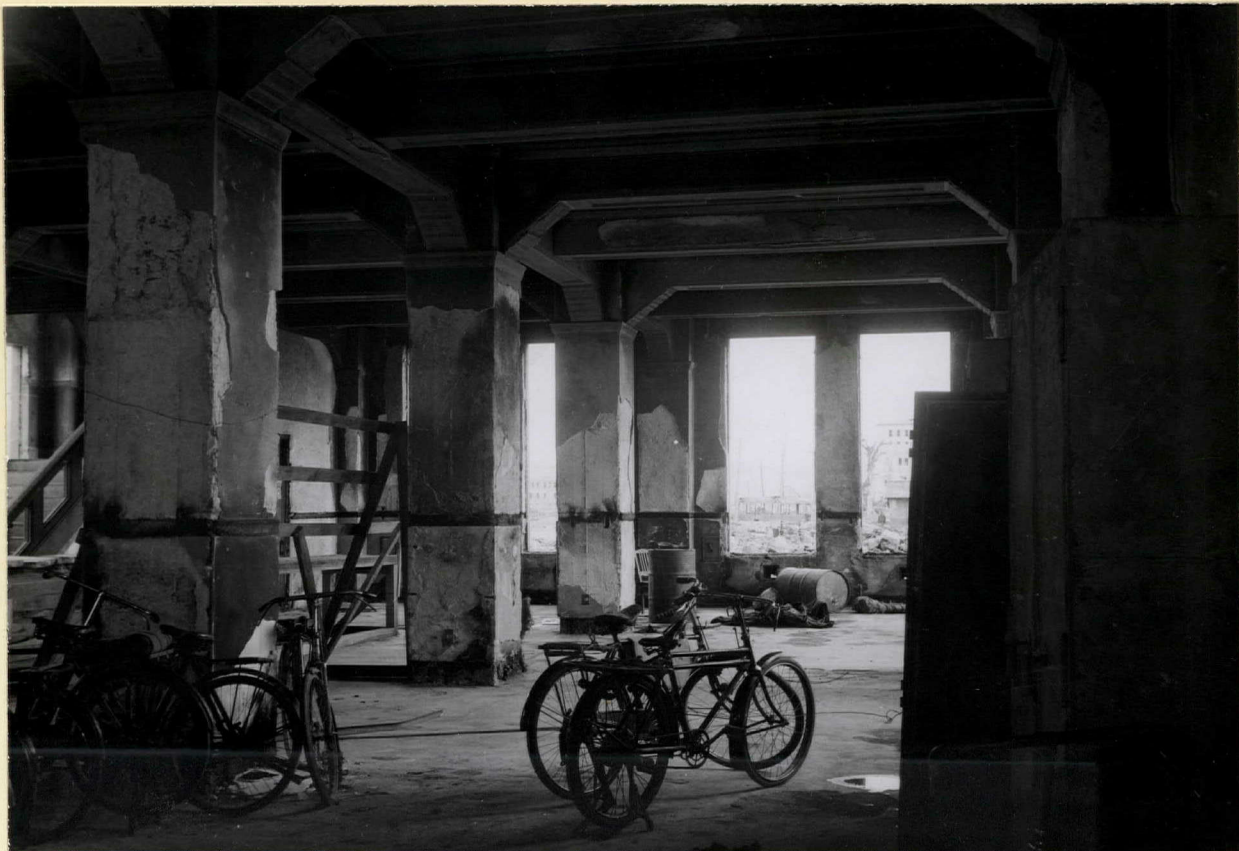
Figure 30 (11H). Chugoku Electric Bldg. (750 meters). Room III - 2, third floor. Looking toward the center of the explosion. Compare with figure 26.

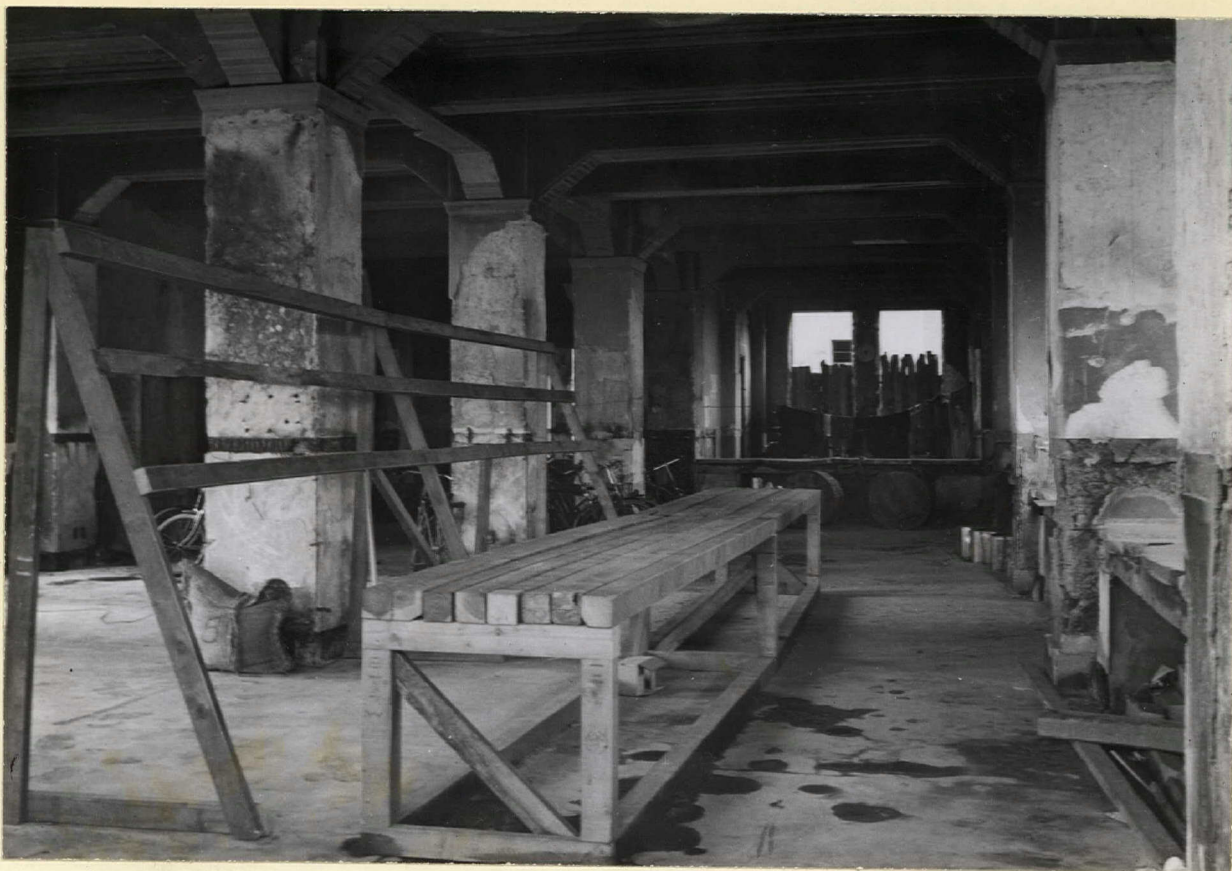
Figure 31 (11H). Chugoku Electric Bldg. (750 meters). Room I 1, first floor. The camera is pointed toward the center of the explosion. Compare with figure 27.

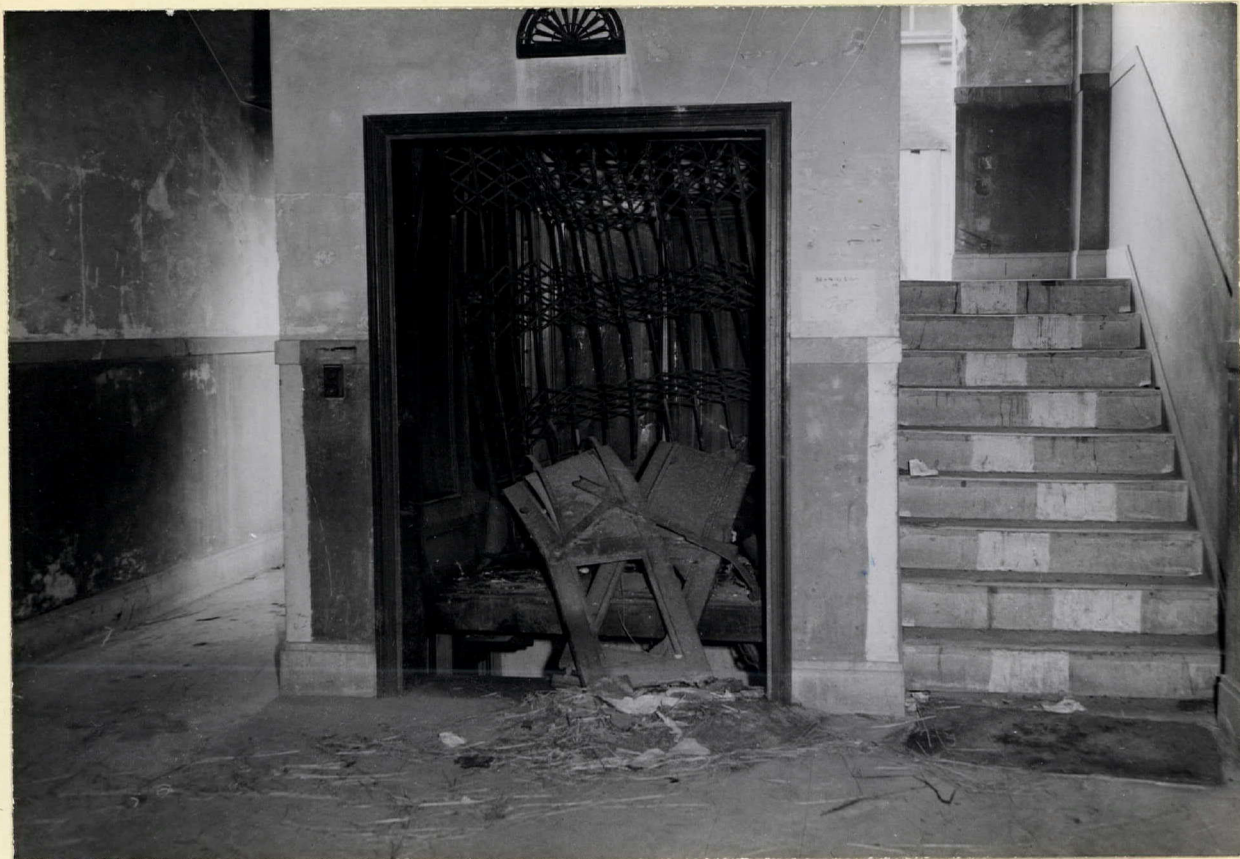
Figure 32 (11H). Chugoku Electric Bldg. (750 meters). Room I,1, first floor. The camera is pointed in a direction opposite to that in figure 29, i.e. along a ray projected from the center of the explosion. Compare with figure 27.

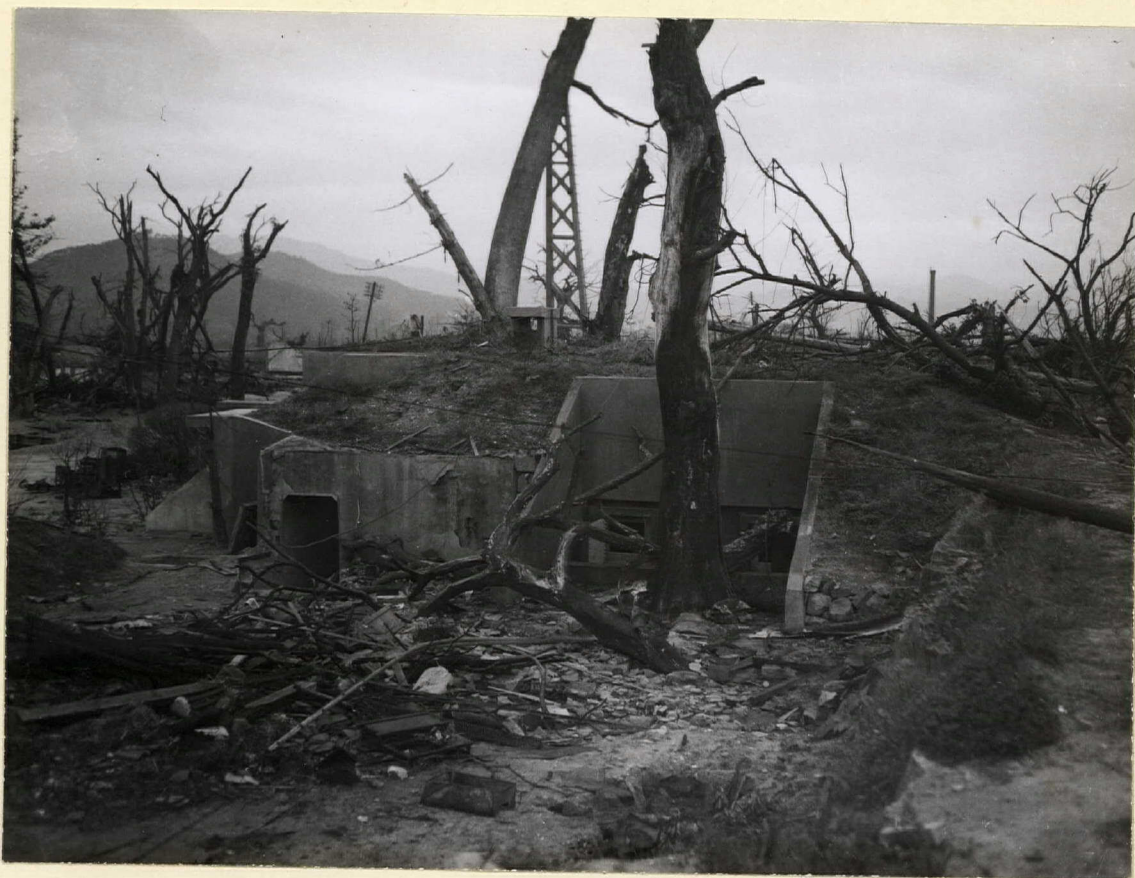
Figure 37 (11H). Chugoku Army Hq., (750 Meters). Underground Communications trench. Open metal port. Looking away from the center of the explosion, with which the optical axis of the camera is in line.

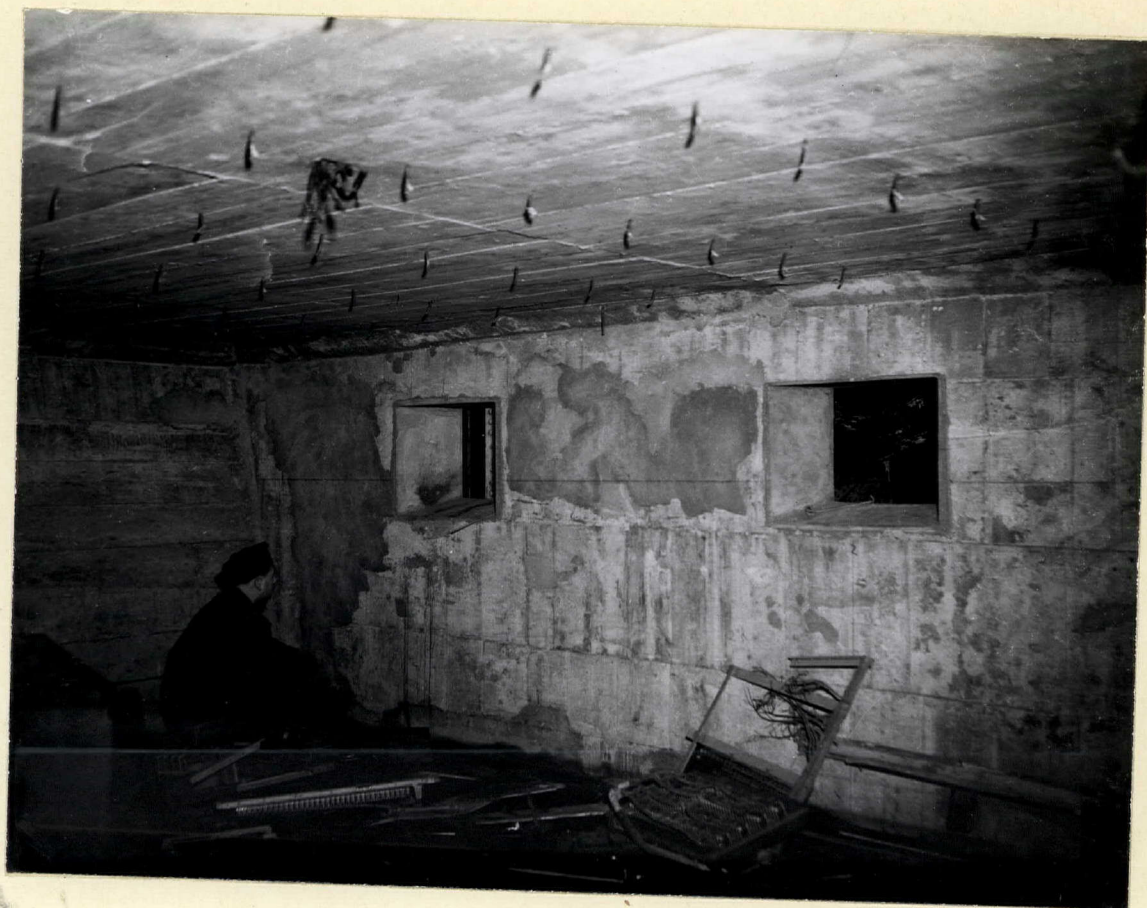
Figure 38 (LLH). Chugoku Army Hq. (750 meters). Underground Communications trench. Entrance at left.

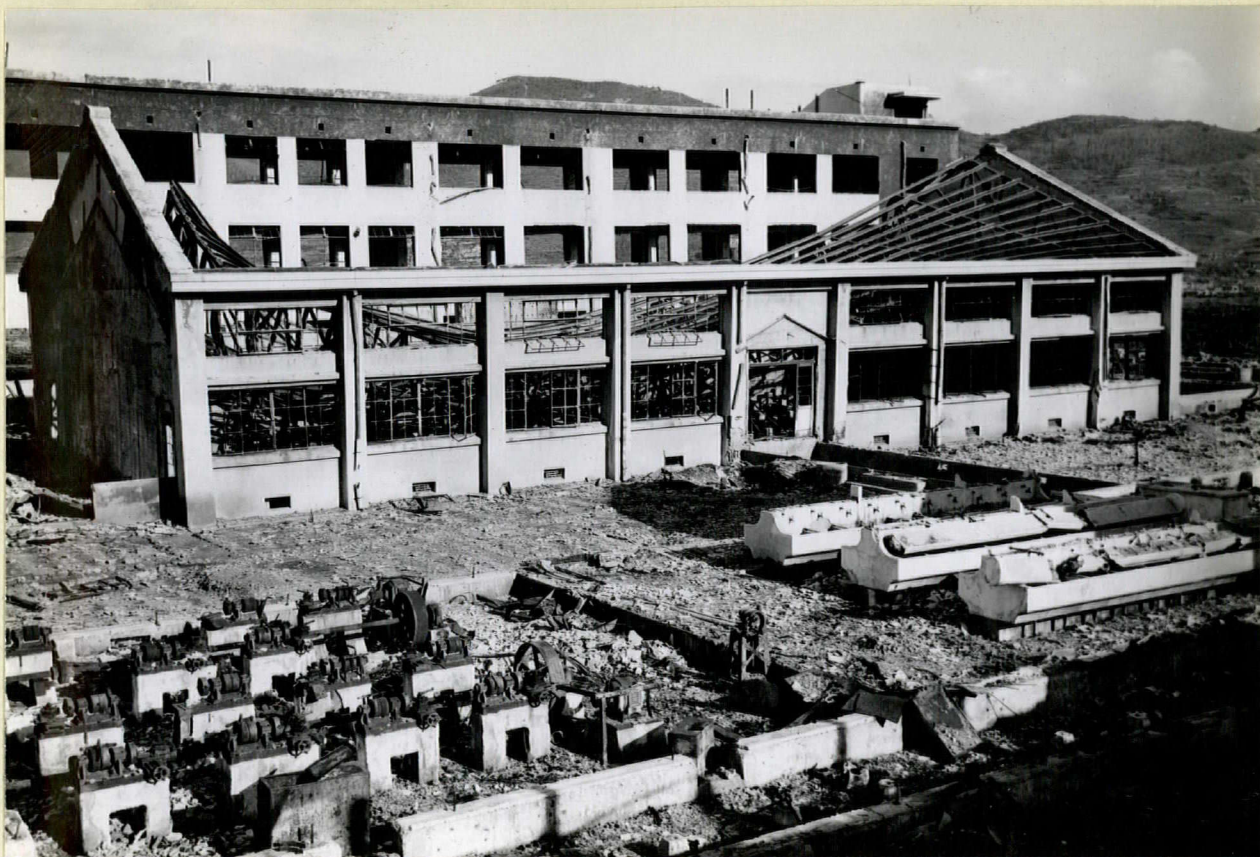
Figure 2 (11 N). Fuchi School. 1000 meters.  
General view looking southeast over damaged area. The school is in the center of the picture. The foundation stones of the wooden portions which were totally demolished can be seen.

(1) Fuchi School is located on a low bluff approximately 1000 meters south of the center (See map, figure 1). It was built on a series of terraces and consisted of a single, heavy reinforced concrete portion three stories in heights which faced to the northeast. Two-story frame buildings surrounded a central courtyard and were attached to the concrete structure. Within the courtyard were several small shops, some of frame, and one of light steel and concrete construction. Behind the main courtyard was a terrace, also enclosed by the frame buildings which served as a playground. The various frame portions of the school were joined to each other by concrete fire-stairs. The main building which faced the blast was of heavy construction with walls 9 inches in thickness. The roof slab was  $3\frac{1}{2}$  inches thick, covered with a layer of tar and tile. The floor slabs were  $4\frac{1}{2}$  inches thick. On 9 August the students had not reported for school in accordance with existing regulations

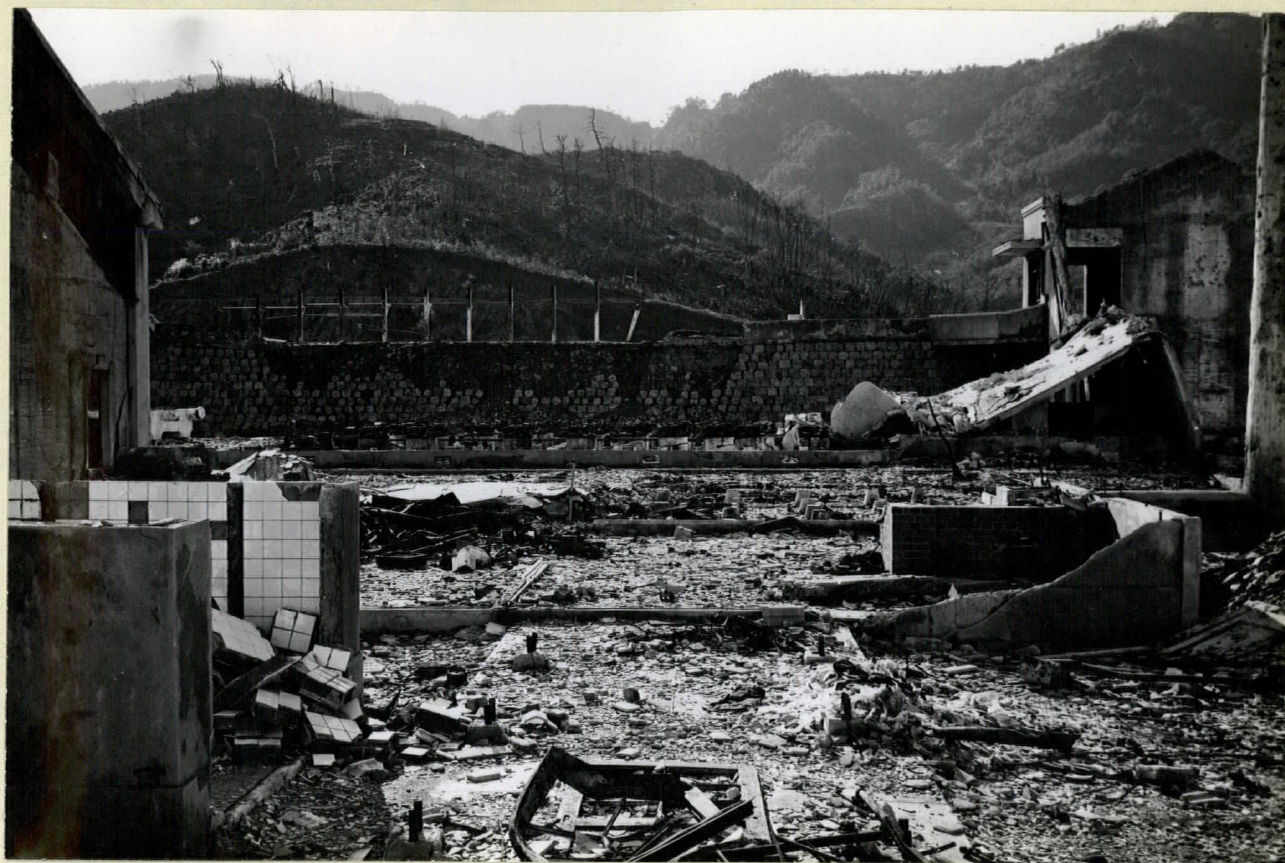
Scene is the courtyard showing the machine shops, and the caved in roof of a light steel and concrete shop. Fire has destroyed all the blasted structures.
